AGRICULTURAL LAND AND WATER RESOURCES DEVELOPMENT COURSE

# **DESIGN OF HEADWORKS**

Appendix

**Ministry of Agriculture, Forestry and Fisheries (MAFF)**

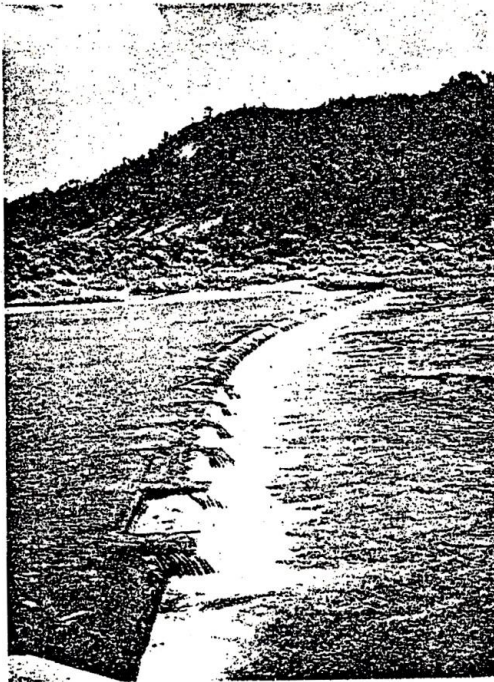
Fig. 5  
Fukagawa Head works (1930)

To stabilize the intake temporary weir by gabion was made for some years, and finally, construction of fixed type weir was planned, and completed in 1930.

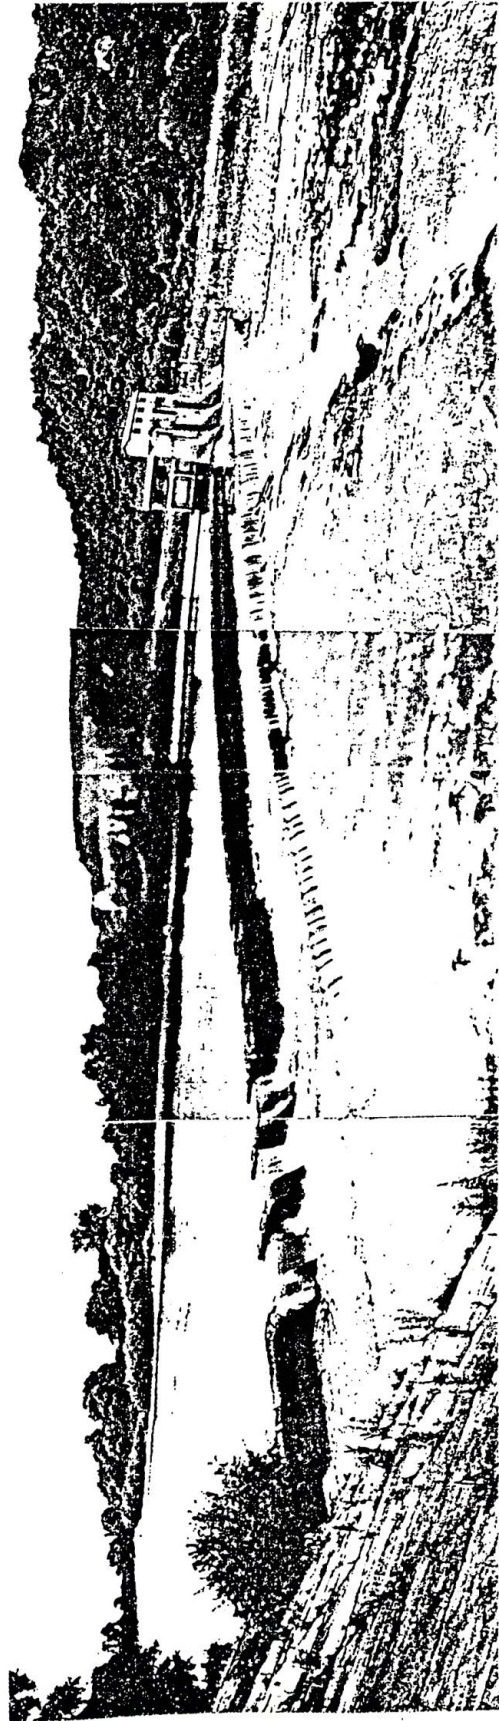
Fig. 6; Fukagawa Head Works (after installation of flushing gate)

(Photo taken in 1975)

During the draught, they often installed the wooden plate to dam up for the increasing of irrigation water, but this load the water right-quarrel along the river, especially between - The Sorachi - system. To solve this quarrel, the government planned additional construction, to move the lower intake to the weir-site, with the heightening of fixed weir, and installation of sediment flush gate in 1950.
